Property Inspection Report
of
Woodford Farm

Prepared For
Mr. John Woodhead
February 23, 2007

By Home Maintainers Inc.
415 Lafayette Avenue
Excelsior, MN 55331
612-267-3958

Property Located at:
3122 50th Street SE
Delano, MN 55328-8109

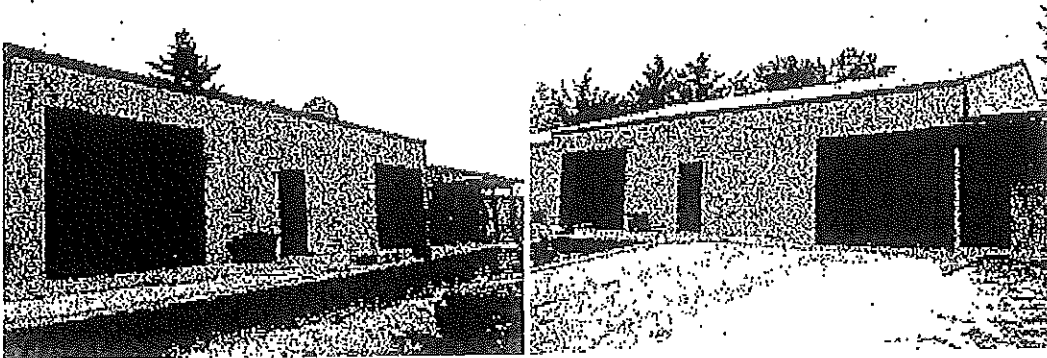
This building is the YELLOW building in the property overview. It is clad in both plywood siding and metal. It has a loading dock, a ramp to the dock height doors as well as ground level access. It is divided into two distinct sections which have no internal connection between them. Within the building(s) there is boat storage, an office, general storage, a bathroom and a photographic dark room. It is a single story building with a slab on grade foundation.

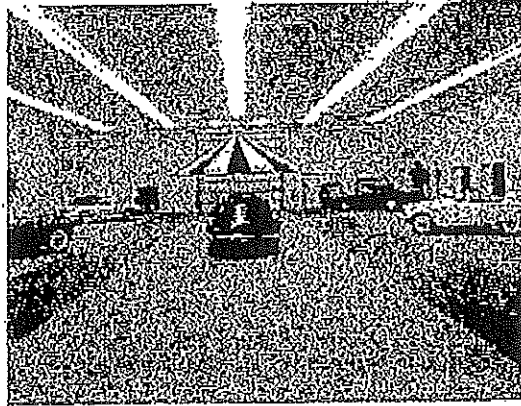
This building is the GREEN building in the property overview. It is a metal clad pole barn with a slab on grade foundation. It is being inspected entirely as a commercial building. It consists of offices, bathrooms, showrooms, automotive detailing shop and storage.

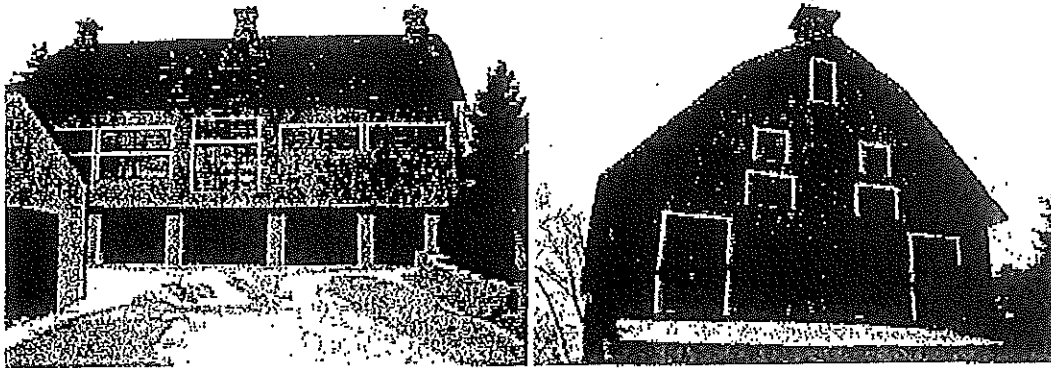
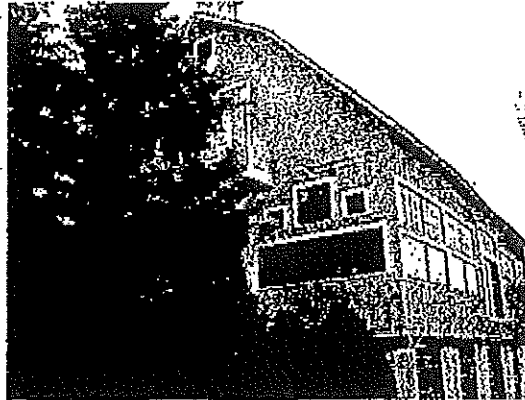
This building is the AQUA BLUE building in the property overview. It is an actual barn that has been converted into a public gathering space. There is a multi-car garage that has been added under the building and a small bedroom in a loft overlooking the main space.

As noted, this is a BARN. It's structure is that of a barn post and beam construction. We did not consider any bowing of the exterior walls or any "wobble" in the soffits a defect. The building is structurally sound.

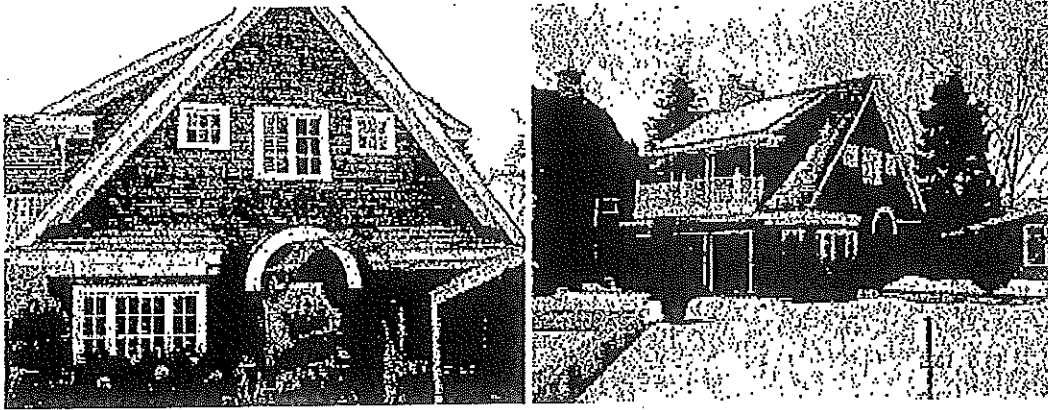
This building is the DARK BLUE building in the property overview. It is the newest building on the property having been built sometime in 2003.

It is a regular house, that will be inspected as such.
